# TEST REPORT

## STANDARD TEST METHOD FOR MEASURING SURFACE FRICTIONAL PROPERTIES USING THE BRITISH PENDULUM TESTER ASTM E303-22

**Sicaro Safariwood, Light Brown, Timber Decking,  
9x30cm**

## TEST REPORT - Wet Pendulum Slip Resistance Classification (US Standard)

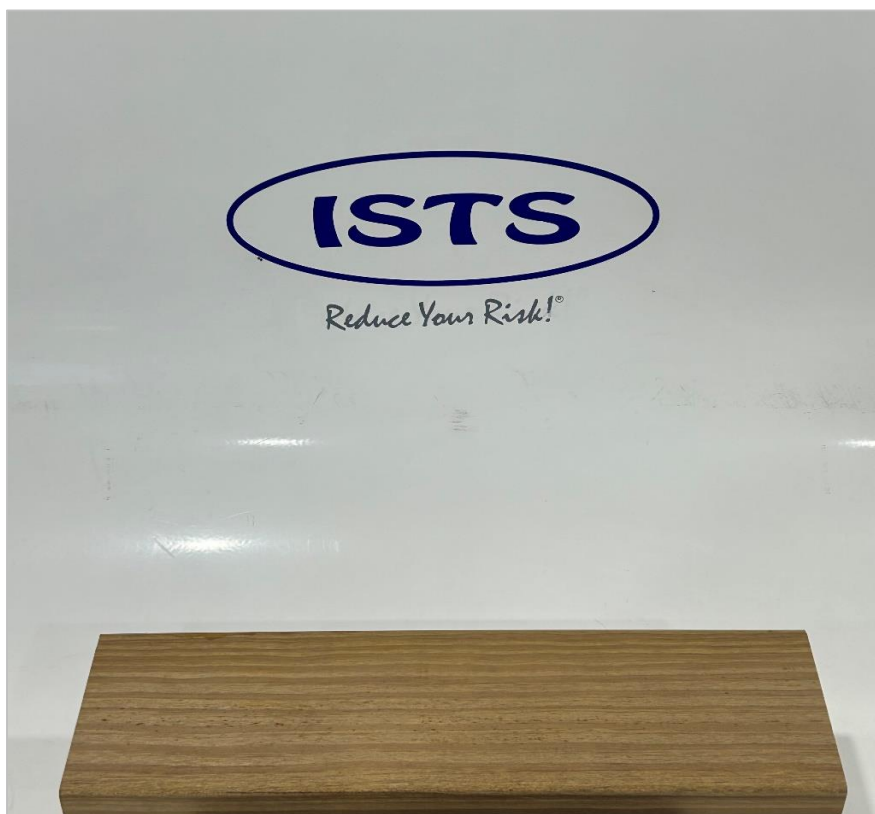
## TEST PRODUCT IMAGE

**Product Description:** Sicaro Safariwood, Light Brown, Timber Decking, 9x30cm
